NATIONAL WESTERN STOCK SHOW  
ENVIRONMENTAL ASSESSMENT REVIEW

August, 1990

Reference: National Western Stock Show  
Environmental Assessment Report Review  
National Western Stock Show Additions  
Southwest of 47th Avenue and Humboldt Street  
Denver, Colorado

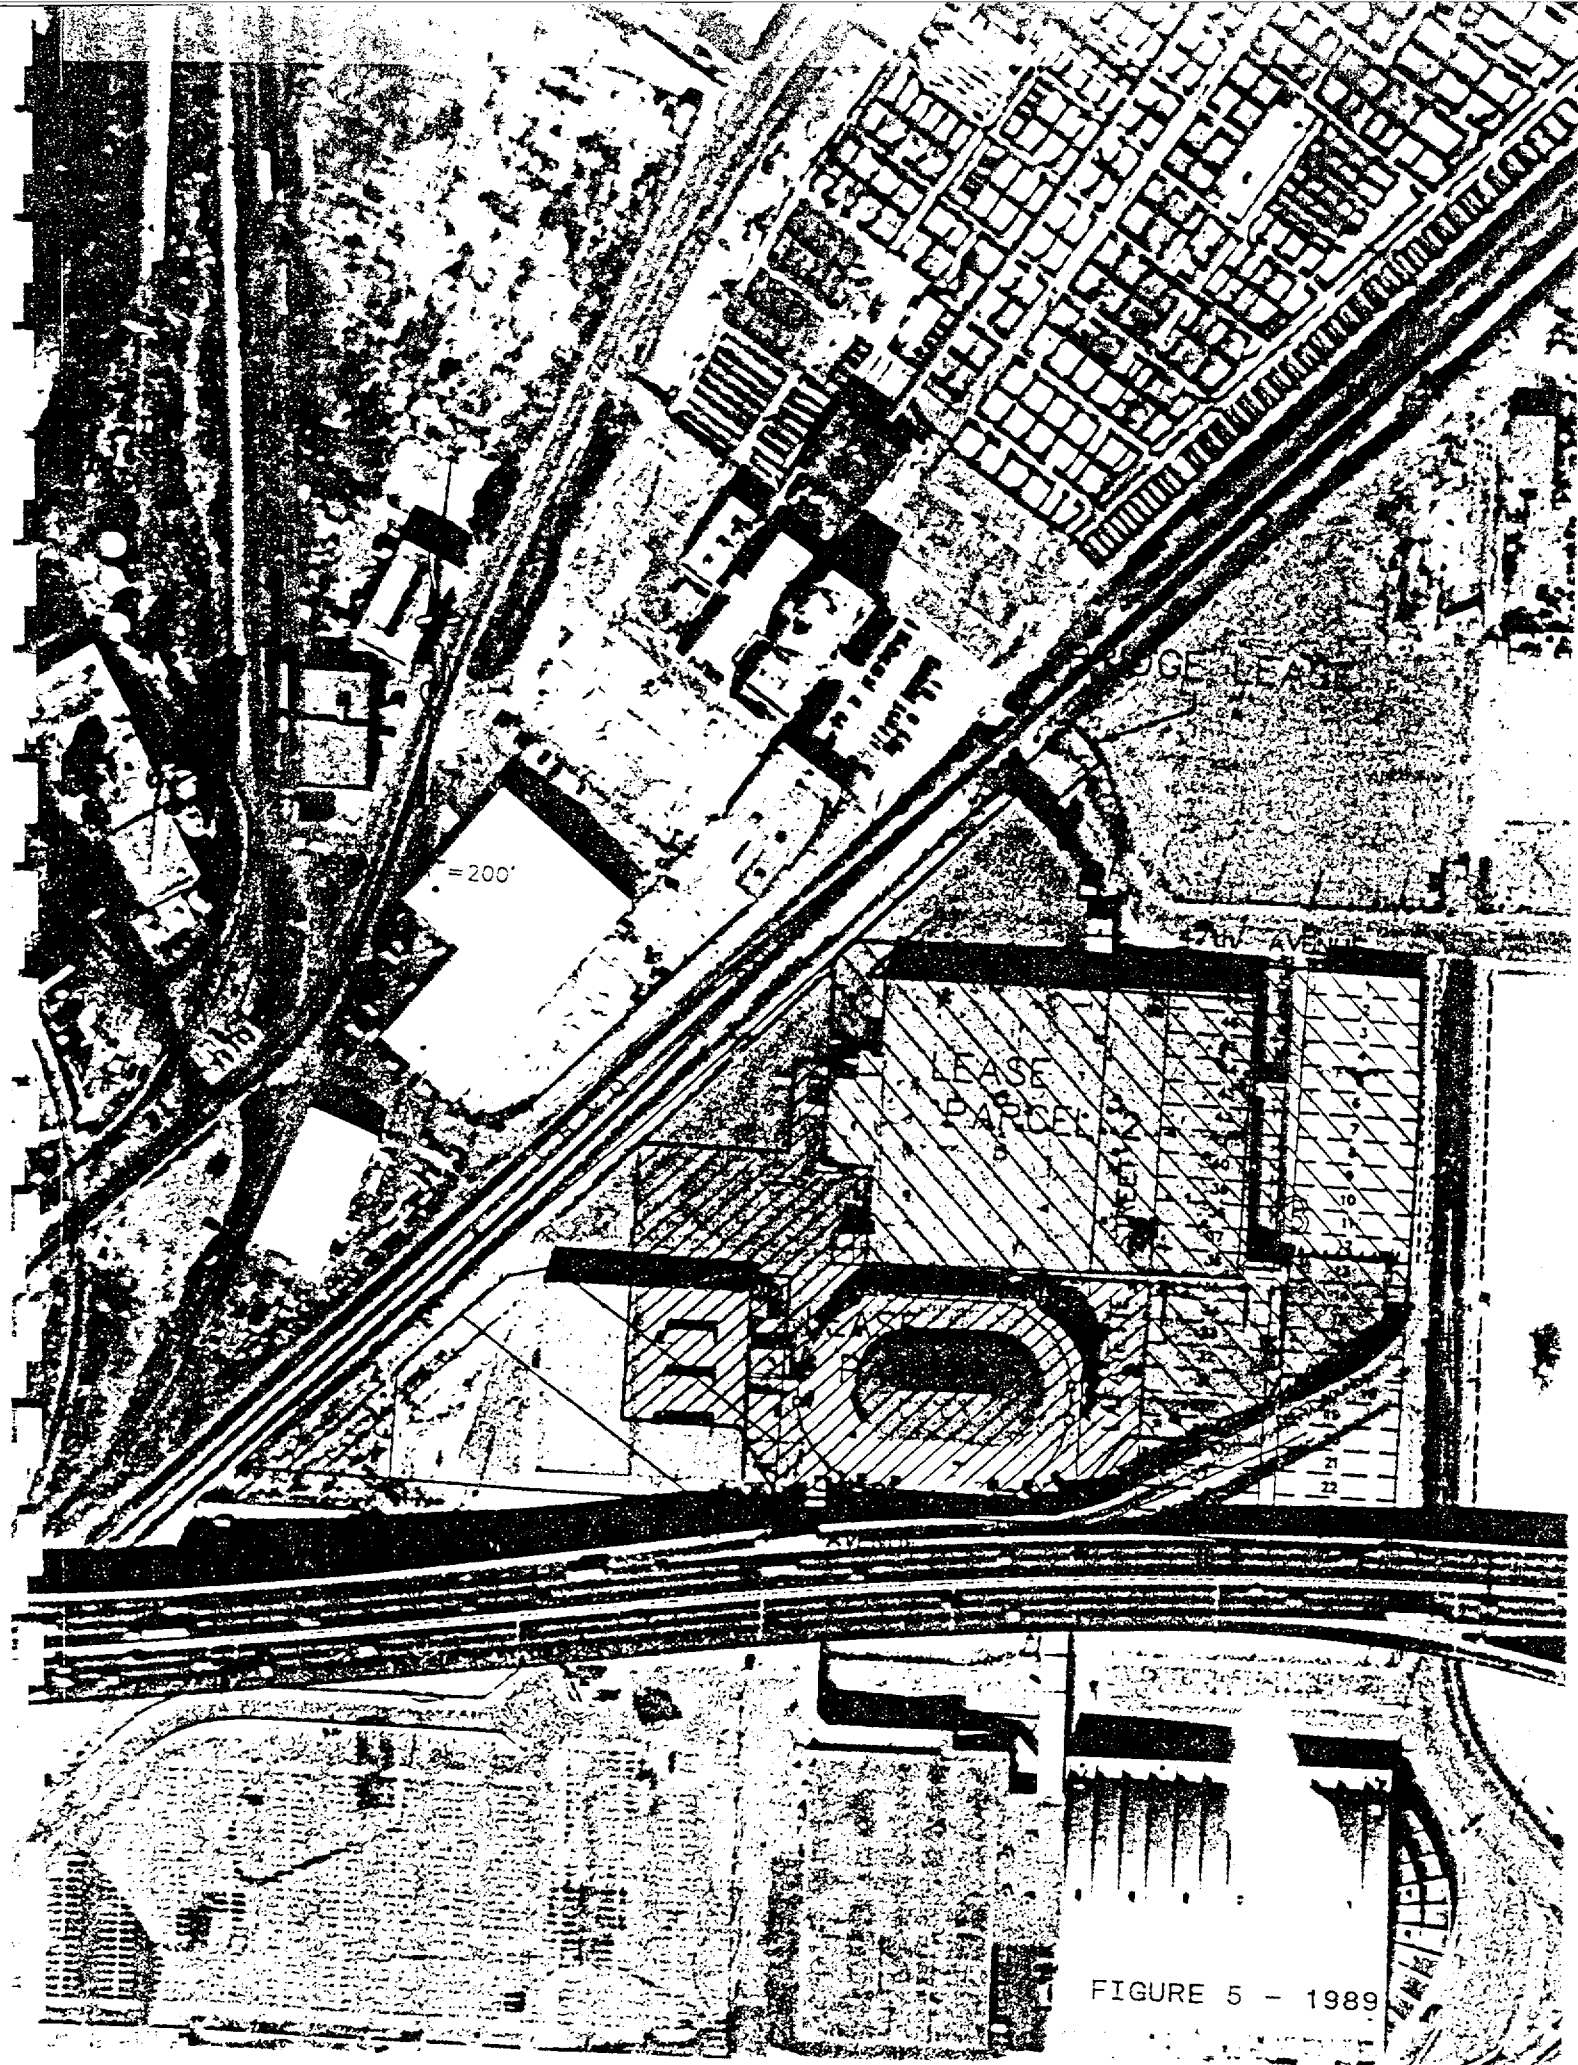
FIGURE 5 - 1989

There are several conditions surrounding Parcels 1a and 2 which were evaluated to determine if there was any adverse effect on the subject parcels. These conditions are shown on the overlay of a 1989 photograph on Figure 5. Those items of concern are former underground storage tanks at previous businesses identified as Jerry's Garage, Yockey Trucking and a service station northeast of the corner of Lafayette Street and 46th Avenue. An additional concern was a small building southwest of the arena in which cattle were sprayed with an insecticide.

As noted on the Figure 4 photograph, there was a service station located on the northeast corner of 46th Avenue and Lafayette Street. As can be shown on the more recent photograph (Figure 5), the service station site has been covered over by the construction of the I-70 westbound entrance ramp. This construction was completed nearly 30 years ago. The Colorado Department of Highways was contacted to determine if records were kept of tank removals during that period. The Department responded by saying that it was possible but not likely that information would be available.

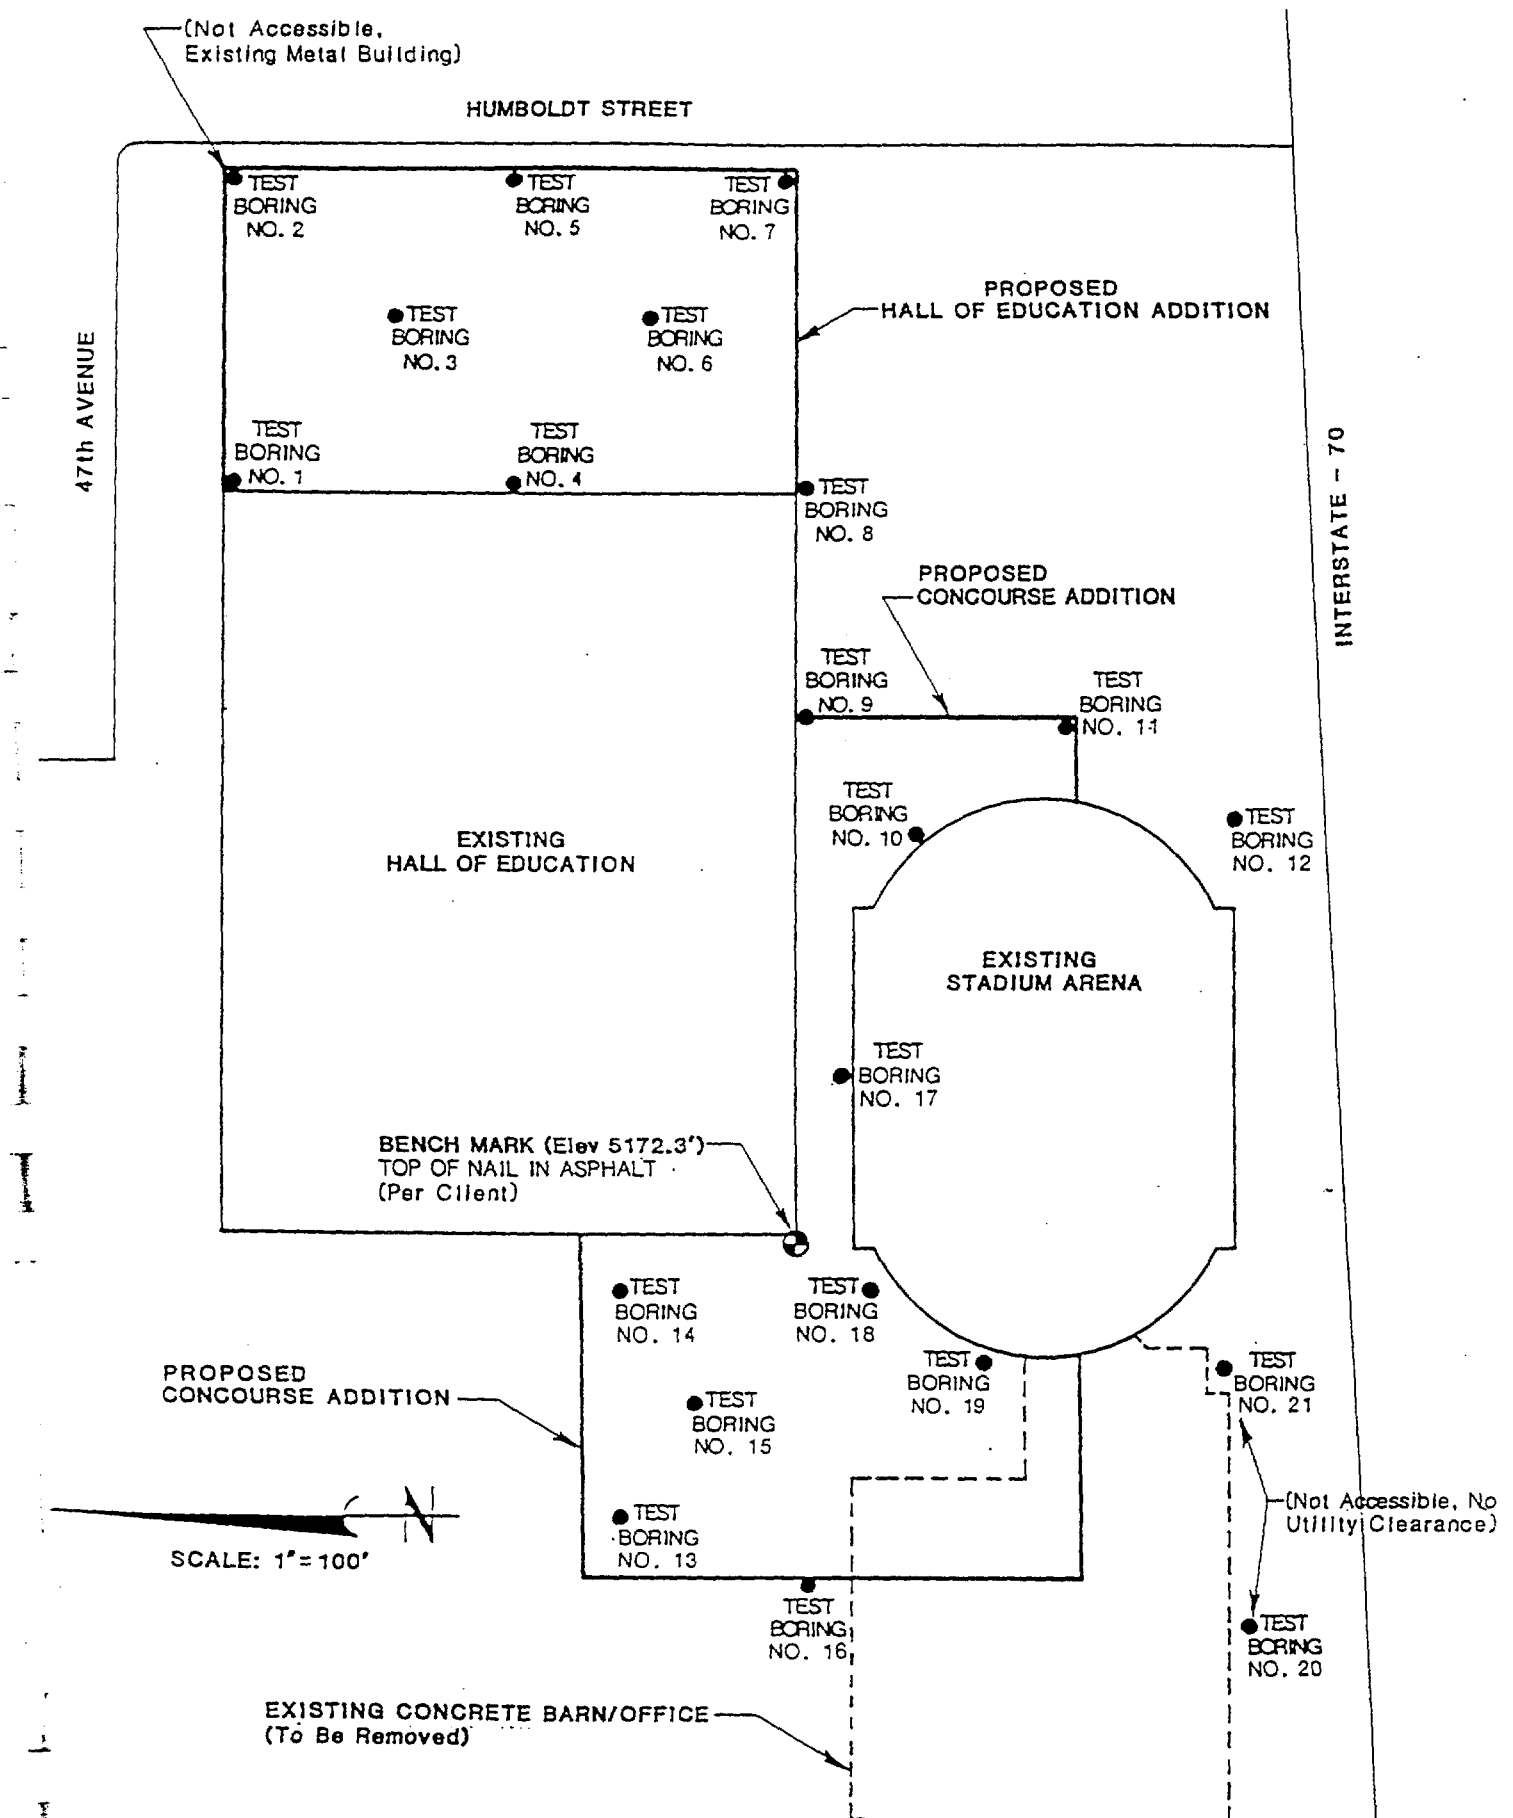
SITE PLAN  
LOCATION OF EXPLORATORY BORINGS  
FIGURE 1

Subsurface conditions were explored by drilling eighteen (18) test borings at the locations indicated on Figure 1. The borings were advanced using both a 4-inch diameter, continuous flight auger and a 6-inch hollow stem auger. Both drilling tools were powered by a CME 55 drilling rig. At frequent intervals, samples of the subsoils were taken using a California sampler which is driven into the soil by dropping a 140-pound hammer through a free fall of 30 inches. The California sampler is a 2.5-inch outside diameter by 2-inch inside diameter device. The number of blows required to drive the sampler into the soils is known as a penetration test. The number of blows required for the sampler to penetrate 12 inches gives an indication of the consistency or relative density of the soils encountered. Results of the penetration tests and locations of sampling are presented on the Logs of Exploratory Borings, Figures 2 through 6.

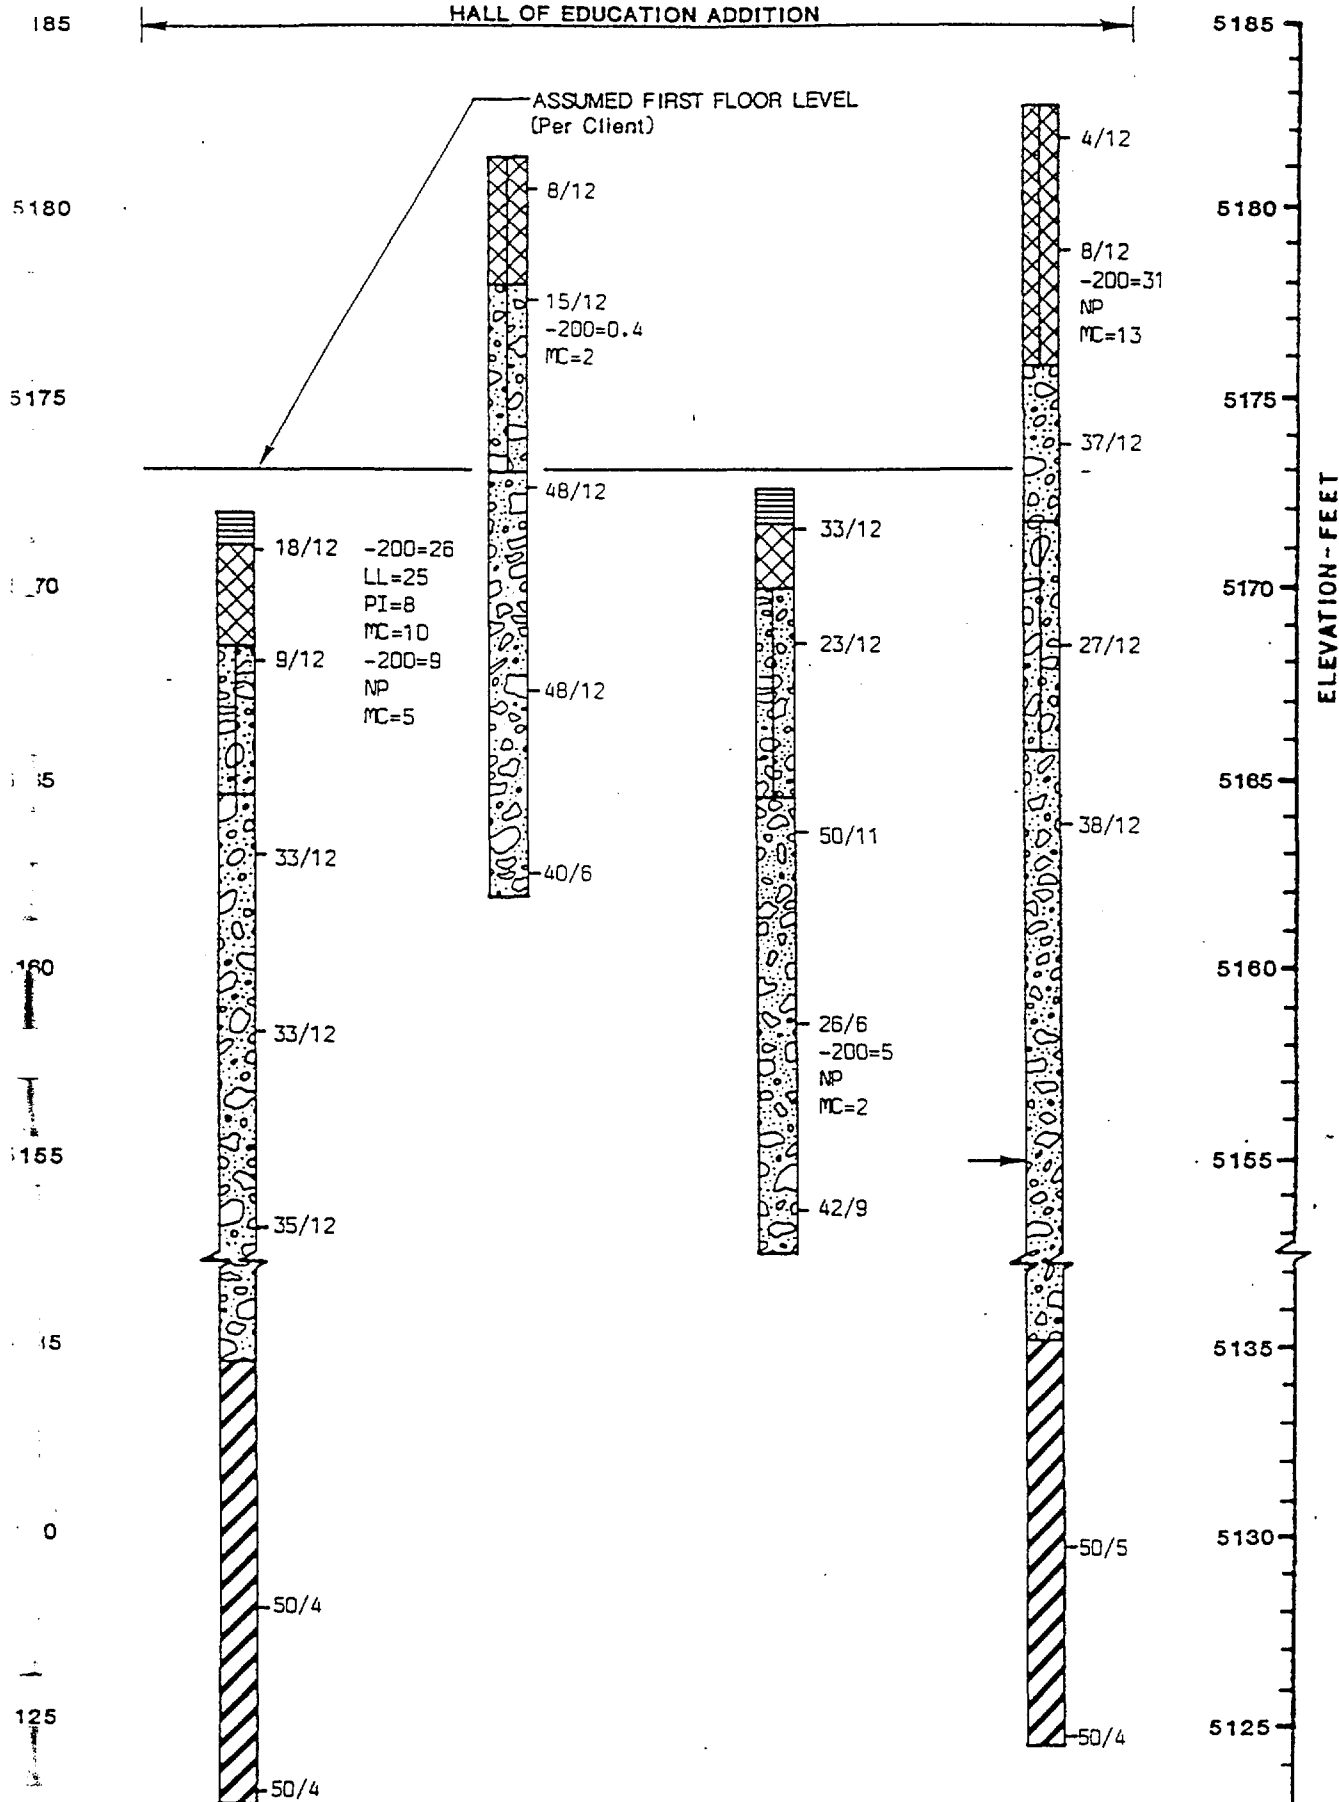
FIGURE 2

Refer to the Logs of Exploratory Borings, Figures 2 through 6, for a more complete description of subsurface conditions.
